# Unmanned Aerial Vehicle-Assisted Assessment of Cable-Stayed Bridge Slant Cables and Piers: Methods and Applications

**Abstract**—This study focuses on the structural integrity assessment of the slant cables and piers of the Damen Bridge in Wenzhou City using unmanned aerial vehicle (UAV) technology. By integrating rotary-wing UAVs, high-resolution cameras, and other advanced inspection equipment, we achieved a comprehensive inspection of critical structural components of the bridge. During the inspection process, each slant cable was subdivided to ensure complete image capture. Additionally, high-definition videos of the piers were recorded from various angles using UAVs. Through the analysis of these high-quality imaging data, a total of 141 structural defects were identified, including 117 in the slant cables and 24 in the piers. Furthermore, advanced image processing and data analysis techniques were applied to analyze the captured data in detail, accurately pinpointing the specific locations and nature of the defects. The results of this study not only demonstrate the effectiveness of UAVs and digital imaging technology in bridge inspection and maintenance but also provide c

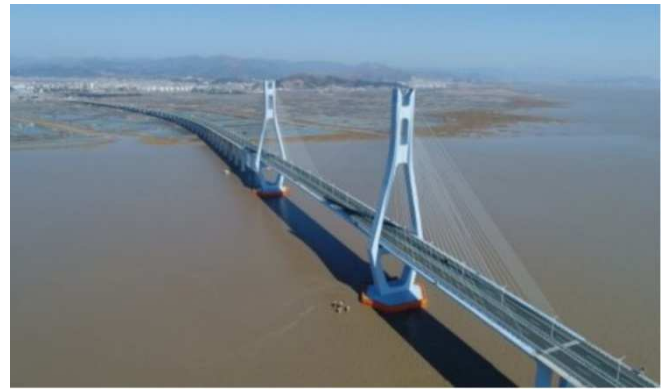
Fig. 1. The Damen Bridge in Wenzhou City

Our work lies in the assessment of cable-stayed bridge slant cables and piers, in particularly, with case studies on Damen Bridge in Wenzhou City. As depicted in Figure 1, the Phase I project of the Damen Bridge serves as a crucial infrastructure connecting Yongqiang Town of Yueqing City with the Daomen Islands of Dongtou District. This bridge plays a vital role in both transportation and the economy. The project's main line begins south of the second middle school in Yongqiang Town, Yueqing, and ends at the petrochemical industry base in Wenzhou City, adjacent to the Wenzhou Port, one of the three major hub ports in the region. The total length of the project's main line is 7,487 meters, with the bridge section spanning 6,155 meters and the remainder comprising roads and related facilities.

The key main bridge structure is located in the second contract section of the project, with pile numbers ranging from K3+867.0 to K4+453.0. The main bridge is designed as a double-tower, double-cable-plane prestressed concrete (PC) cable-stayed bridge with a span combination of (135+316+135) meters. The cable-stays are arranged in a fan-shaped configuration, with each tower equipped with 22 pairs of cable-stays, totaling 176 cables. Additionally, the main beam is designed as a prestressed concrete ribbed slab structure, featuring a main rib height of 2.8 meters and a width of 2 meters. The bridge deck consists of 0.3-meter-thick unidirectional load-bearing slabs, with transverse beams set every 6.6 meters, each 0.4 meters thick. The main tower features a unique vase-shaped design, with a total height from the base to the top of the tower of 136 meters, including segments of various heights in straight and curved lines. The tower's top has a lateral width of 13 meters, while the bottom width is 43 meters. The overall design of the bridge not only addresses the structural and engineering requirements but also focuses on aesthetic appeal and harmonious integration with the environment.

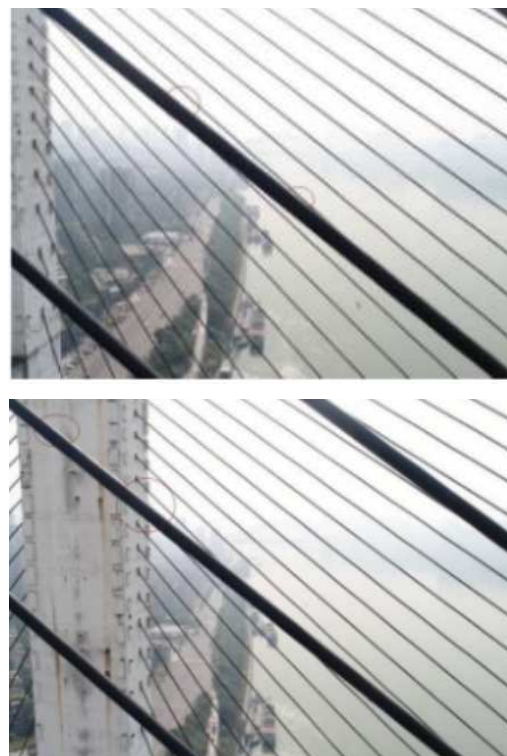
Fig. 2. Image-Annotated Diagram of the Cable-Stay Crack Locations (Cable NX-16 crack)

base to the top of the piers, recording high-definition videos of each side to ensure that every part of the piers was thoroughly inspected. In the acquired videos and images, advanced image processing techniques were used to extract and annotate damages on the cable-stays and piers, such as marking the locations of cracks in the cable-stays as shown in Fig 2. This included the identification and documentation of potential issues such as cracks and corrosion. With this method, we were able to effectively assess the overall health of the bridge and provide accurate data support for subsequent maintenance work.
